**Flood Control Project Maintenance  
Levee Inspections**  
**LMA District Cover Sheet**  
**Spring 2018 Levee Inspection Results**

**Lake County Watershed Protection District**

**Spring 2018 Levee Inspection Results**

Waterway	Bank	Unit Miles
Unit No. 01 Middle Creek	Left	3.35

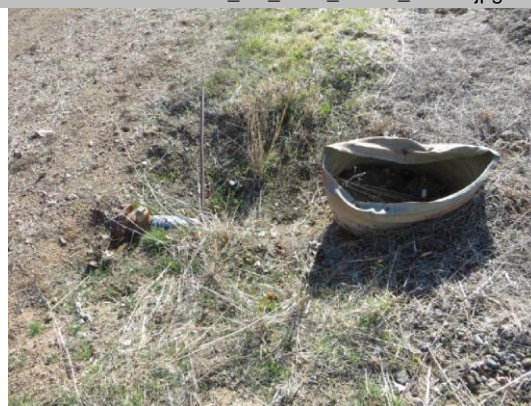
Photo 1 of 3 : UCIP\_SP\_2018\_26943\_49782.jpg

Comment Code					
Inspector Comment					
FS_ID:26943 DS_ID:21193 EP_NO: 5237 Repair Type: Non-Urgent Crossing Status: Found UCIP Comments: Pipe appears abandoned and should be done so properly. FIELD_STRUCT_DESC: *ABANDONED* 6-inch coated steel irrigation pipe possibly sleeved through an 8-inch steel pipe, 3 feet below the crown. Siphon breaker in 24-inch corrugated metal riser unit on the landside (LS) slope. Reinforced concrete cutoff wall at center of levee. Butterfly valve on the waterside (WS) at pump on concrete base on the WS bank. Pole on the WS berm with overhead power line supplying electricity to the pump. (Installed under Permit No. 5237, 1966 - Moitozo Brothers, Inc.). [Additional Reference(s): DWR Levee Log, 2005. USACE Sacramento O&M Manual 506.2, August 1961, (HLM 0.54)]. FS Date: 1/9/2014

Pipe and siphon breaker visible on LS slope.

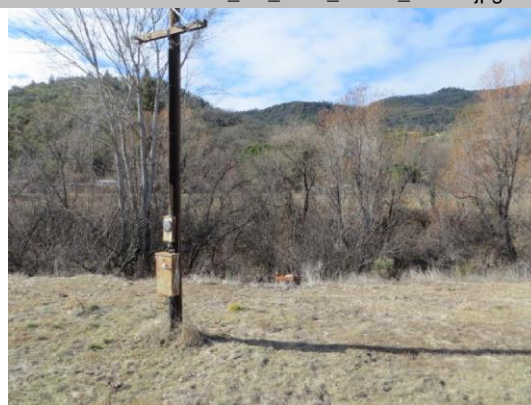
Photo 2 of 3 : UCIP\_SP\_2018\_26943\_49781.jpg

Power pole, meter, and pump visible on WS berm.

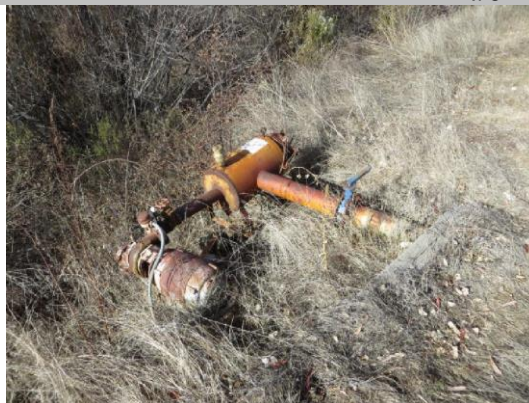
Photo 3 of 3 : UCIP\_SP\_2018\_26943\_49780.jpg

Comment Code						
Inspector Comment						
FS_ID:26943 DS_ID:21193 EP_NO: 5237 Repair Type: Non-Urgent Crossing Status: Found UCIP Comments: Pipe appears abandoned and should be done so properly. FIELD_STRUCT_DESC: *ABANDONED* 6-inch coated steel irrigation pipe possibly sleeved through an 8-inch steel pipe, 3 feet below the crown. Siphon breaker in 24-inch corrugated metal riser unit on the landside (LS) slope. Reinforced concrete cutoff wall at center of levee. Butterfly valve on the waterside (WS) at pump on concrete base on the WS bank. Pole on the WS berm with overhead power line supplying electricity to the pump. (Installed under Permit No. 5237, 1966 - Moitozo Brothers, Inc.). [Additional Reference(s): DWR Levee Log, 2005. USACE Sacramento O&M Manual 506.2, August 1961, (HLM 0.54)]. FS Date: 1/9/2014

Pump and butterfly valve on WS berm.

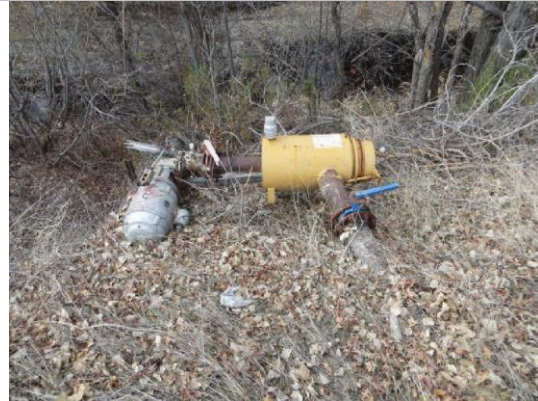
Photo 3 of 3 : UCIP\_SP\_2018\_26946\_49787.jpg

Comment Code						
Inspector Comment						
FS_ID:26946						
DS_ID:21196						
EP_NO: N/A						
Repair Type: Non-Urgent						
Crossing Status: Found						
UCIP Comments: Pump and pipe appear abandoned and should be done so properly.						
FIELD_STRUCT_DESC: *ABANDONED* 8-inch steel irrigation pipe through the levee, 3 feet below the crown. Siphon breaker in 24-inch corrugated metal riser unit on the landside (LS) slope. Pump on the waterside (WS) bank with a butterfly valve. Service pole on the WS berm. (Moitozo Brothers, Inc.). [Additional Reference(s): DWR Levee Log, 2005. USACE Sacramento O&M Manual 506.2, August 1961, (HLM 0.83)].						
FS Date: 1/9/2014

Pump and butterfly valve visible on WS berm.

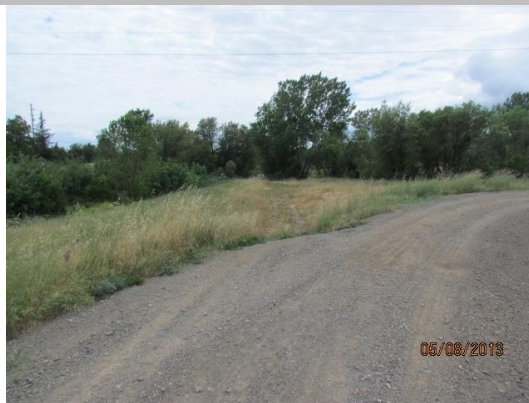
Photo 1 of 1 : SP\_2018\_NA0009\_3\_13\_20180305\_00007.jpg

LM Start	2.29	Rating **	M	Issue No.	13
LM End	2.29	Issue Type +	Ma	Location *	WS
Category	Earthen Levee			GPS Latitude/Longitude	
				Start	End
Item	Slope Stability			39.160285 °	39.160285 °
				-122.913481 °	-122.913481 °
DWR ID	DWR_NA0009_01_s_2013_13				
Comment Code					
S3 : Repair the levee slope damaged by vehicle traffic and prevent access where possible.					
Inspector Comment

View of the vehicle erosion along the waterside slope.

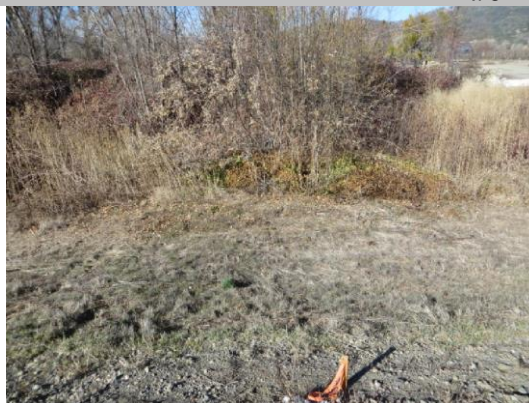
Photo 1 of 3 : UCIP\_SP\_2018\_27004\_49862.jpg

Comment Code					
Inspector Comment					
FS_ID:27004					
DS_ID:21199					
EP_NO: 11460					
Repair Type: Non-Urgent					
Crossing Status: Found					
UCIP Comments: Heavy vegetation on LS at inlet should be removed.					
FIELD_STRUCT_DESC: 42-inch corrugated metal drainage pipe					
through the levee, 10 feet below the crown. Flap gate on the waterside					
(WS) end. Concrete headwall on both ends. (42-inch pipe [HLM 2.35]					
retained under Automatic Board Order (ABO) issued as Permit No.					
11460, 1975 - Robert L. and Lavona Gentry). [Additional Reference(s):					
DWR Levee Log, 2005. USACE Sacramento O&M Manual 506.2,					
August 1961, (HLM 2.35)].					
FS Date: 1/14/2014

Heavy vegetation at inlet on LS toe.

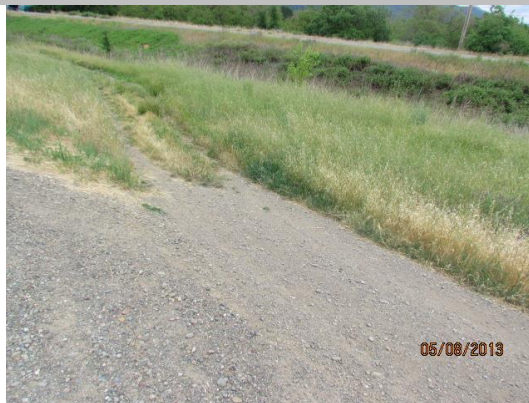
Photo 1 of 1 : SP\_2018\_NA0009\_3\_14\_20180305\_00008.jpg

LM Start	2.36	Rating **	M	Issue No.	14
LM End	2.36	Issue Type +	Ma	Location *	WS
Category	Earthen Levee			GPS Latitude/Longitude	
				Start	End
Item	Slope Stability			39.161153 °	39.161153 °
				-122.912740 °	-122.912740 °
DWR ID	DWR_NA0009_01_s_2013_14				
Comment Code					
S3 : Repair the levee slope damaged by vehicle traffic and prevent access where possible.					
Inspector Comment

View of the vehicle erosion along the waterside slope.

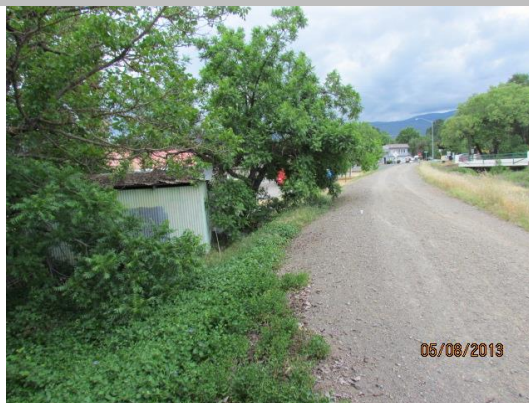
Photo 1 of 1 : SP\_2018\_NA0009\_3\_15\_20180305\_00009.jpg

LM Start	2.38	Rating **	M	Issue No.	15
LM End	2.41	Issue Type +	Ma	Location *	LS
Category	Earthen Levee			GPS Latitude/Longitude	
				Start	End
Item	Trim / Thin Trees			39.161381 °	39.161708 °
				-122.912551 °	-122.912168 °
DWR ID	DWR_NA0009_01_s_2013_15				
Comment Code					
T1 : Trim trees to at least five feet above ground level.					
Inspector Comment					
trim the trees to at least 5 feet above the ground for visibility and remove the vegetation from the slope.

Trim the trees up 5 feet to allow visibility.

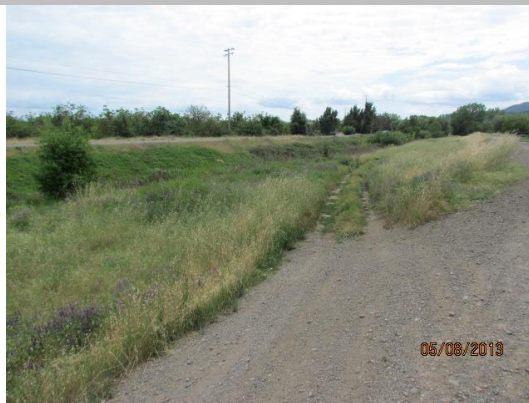
Photo 1 of 1 : SP\_2018\_NA0009\_3\_16\_20180305\_00010.jpg

LM Start	2.40	Rating **	M	Issue No.	16
LM End	2.40	Issue Type +	Ma	Location *	WS
Category	Earthen Levee			GPS Latitude/Longitude	
				Start	End
Item	Slope Stability			39.161601 °	39.161601 °
				-122.912303 °	-122.912303 °
DWR ID	DWR_NA0009_01_s_2013_16				
Comment Code					
S3 : Repair the levee slope damaged by vehicle traffic and prevent access where possible.					
Inspector Comment

View of the vehicle erosion along the waterside slope.

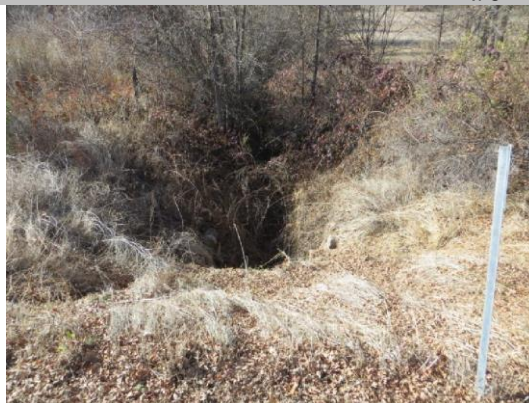
Photo 1 of 3 : UCIP\_SP\_2018\_27066\_50049.jpg

LM Start	0.14	Rating **	A/W	Issue No.	32	
LM End	0.14	Issue Type +	Ma	Location *		
Category	Supplemental			GPS Latitude/Longitude		
				Start		End
Item	DWR UCIP LMA Responsibility			39.187919 °		39.187919 °
				-122.908631 °		-122.908631 °
DWR ID						
Comment Code						
Inspector Comment						
FS_ID:27066 DS_ID:21201 EP_NO: 11485 Repair Type: No Action Needed Crossing Status: Found UCIP Comments: FIELD_STRUCT_DESC: 42-inch corrugated metal drainage pipe through the levee, 8.5 feet below the crown. Flap gate on the waterside (WS). Concrete headwalls on both ends. (42-inch pipe [HLM 0.13] retained under Automatic Board Order (ABO) issued as Permit No. 11485, 1975 - John and Vivian Strickfaden). [Additional Reference(s): DWR Levee Log, 2005. USACE Sacramento O&M Manual 506.2, August 1961, (HLM 0.13)]. FS Date: 1/14/2014

Pipe and headwall visible at LS toe in drainage swale.

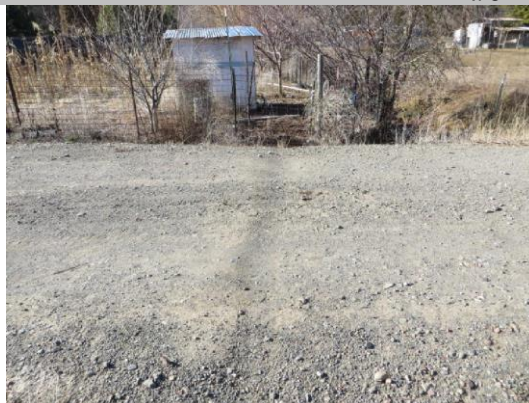
Photo 3 of 3 : UCIP\_SP\_2018\_27563\_51180.jpg

cut across levee crown visible along pipe alignment.

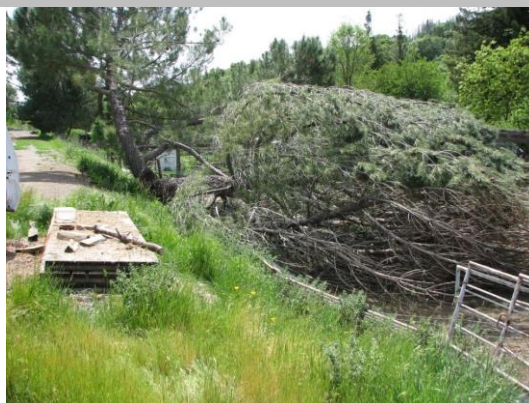
Photo 1 of 1 : SP\_2018\_NA0009\_4\_20\_20180305\_00011.jpg

View of the fallen tree branch on landside slope and toe.

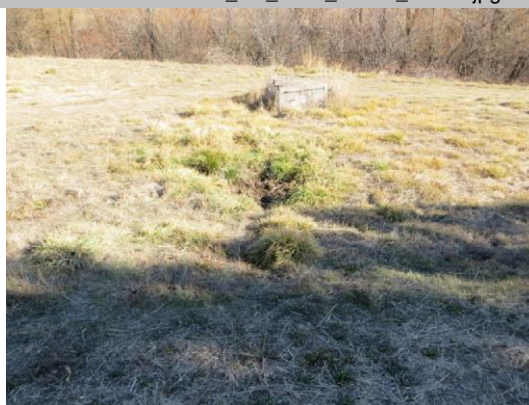
Photo 2 of 3 : UCIP\_SP\_2018\_51435\_50392.jpg

Mudpit at WS berm were pipe may be leaking.

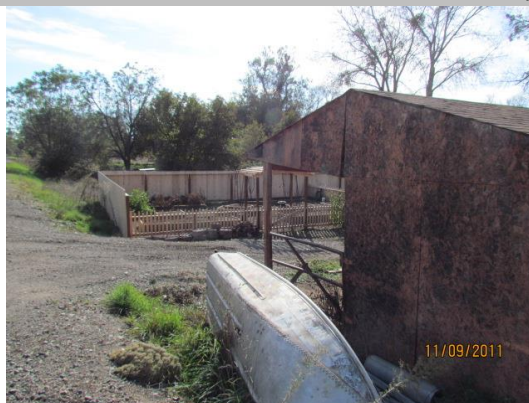
Photo 1 of 1 : SP\_2018\_NA0009\_4\_2\_20180305\_00002.jpg

View of the building &amp; fence along the Landside toe.

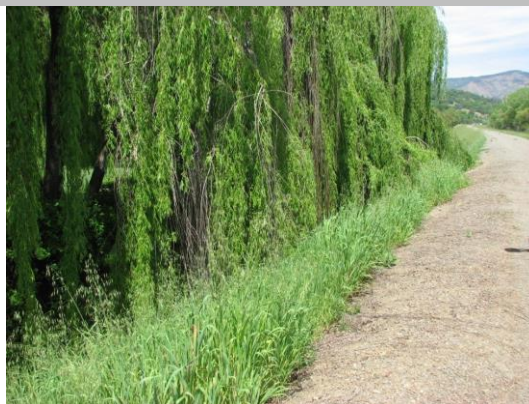
Photo 1 of 1 : SP\_2018\_NA0009\_4\_18\_20180305\_00009.jpg

View of the overgrown willow trees at the landside levee slope.

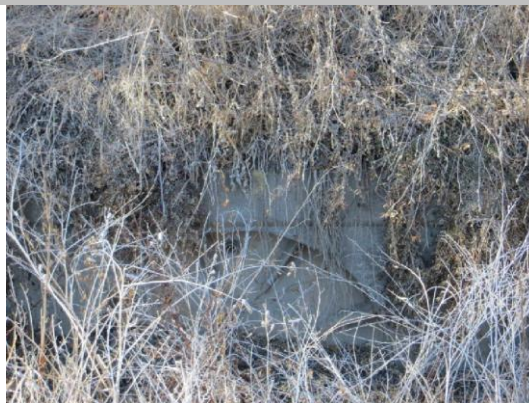
Photo 3 of 3 : UCIP\_SP\_2018\_27893\_51596.jpg

Concrete headwall and plugged pipe visible on LS toe of roadway.

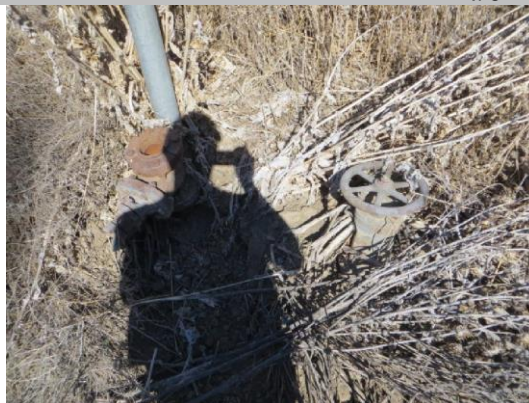
Photo 2 of 3 : UCIP\_SP\_2018\_27903\_51621.jpg

Gate valves at tank appear to be in disrepair.

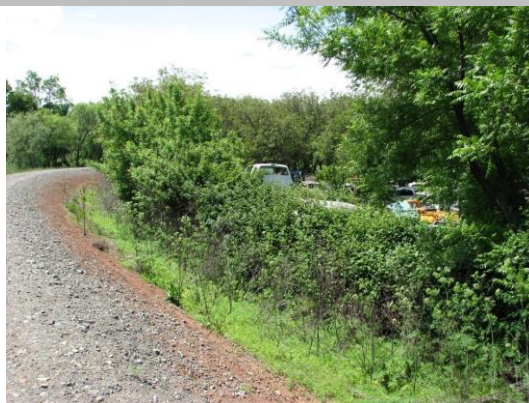
Photo 1 of 1 : SP\_2018\_NA0009\_5\_12\_20180305\_00003.jpg

5/2/2016: Dense bushes and vines covering fence along vehicle junk yard.

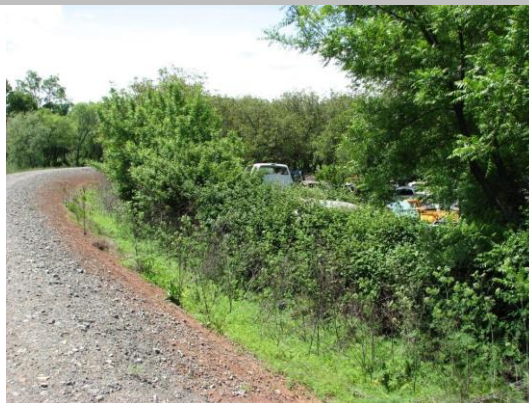
Photo 1 of 1 : SP\_2018\_NA0009\_5\_11\_20180305\_00002.jpg

5/2/2016: Fence along vehicle junk yard is covered in dense growth of bushes and vines.

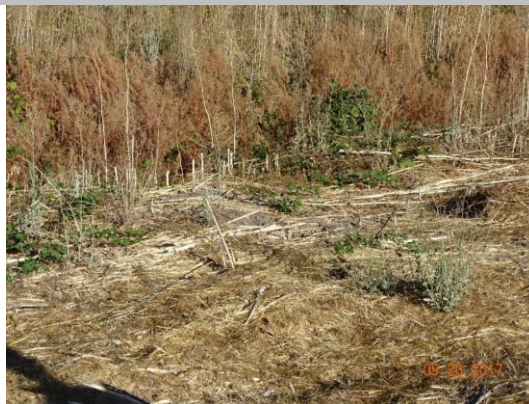
Photo 1 of 1 : SP\_2018\_NA0009\_6\_12\_20180305\_00005.jpg

View of the rodent holes along the landside slope &amp; toe.
